CORROSION OF MATERIALS IN HYDROSPACE

PART IV - COPPER AND COPPER ALLOYS

Technical Note N-961

Fred M. Reinhart

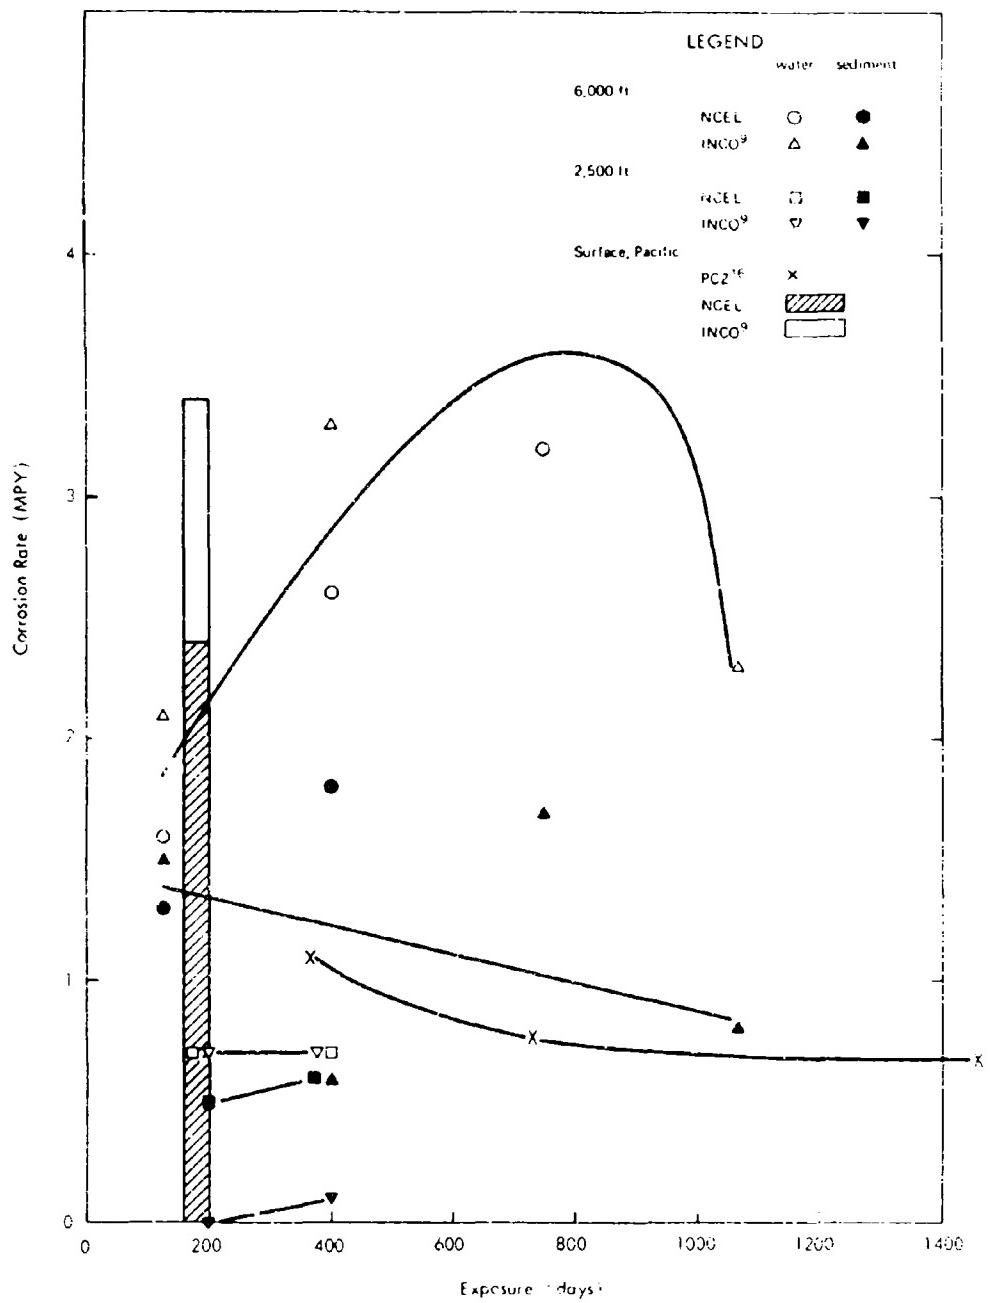
The corrosion of Muntz Metal at the 6,000 foot depth was erratic as shown in Figure 9. This is attributed to the dezincification of the alloy. The corrosion rates at the 2,500 foot depth were essentially constant with time and those in the bottom sediments were lower than those in the sea water. Muntz metal corroded at a higher rate at the surface in the Pacific Ocean than at either depth and at the Panama Canal Zone. Even though Muntz metal was dezincified during exposure at the surface in the Pacific Ocean, Fort Amador, Panama Canal Zone, Reference 16, its corrosion rate decreased asymptotically with time and was lower than at the 6,000 foot depth. Muntz metal suffered from dezincification at the surface and at both depths in the Pacific Ocean, the extent varying from slight to severe. The severity of the dezincification after 751 days of exposure at a depth of 6,000 feet is shown in Figure 10, the thickness of the specimen was reduced by 28 percent. The dark bands on the edges are dezincified areas.

Figure 10. Dezincified Muntz metal,
751 days, 5640 feet. X3.
